FIGURE 3 – Summer photo of the main old gravel haul road at the Glover site.
Chattanooga, Hamilton County, TN (Photo credit: David Borowski, TDH, 6/20/03)

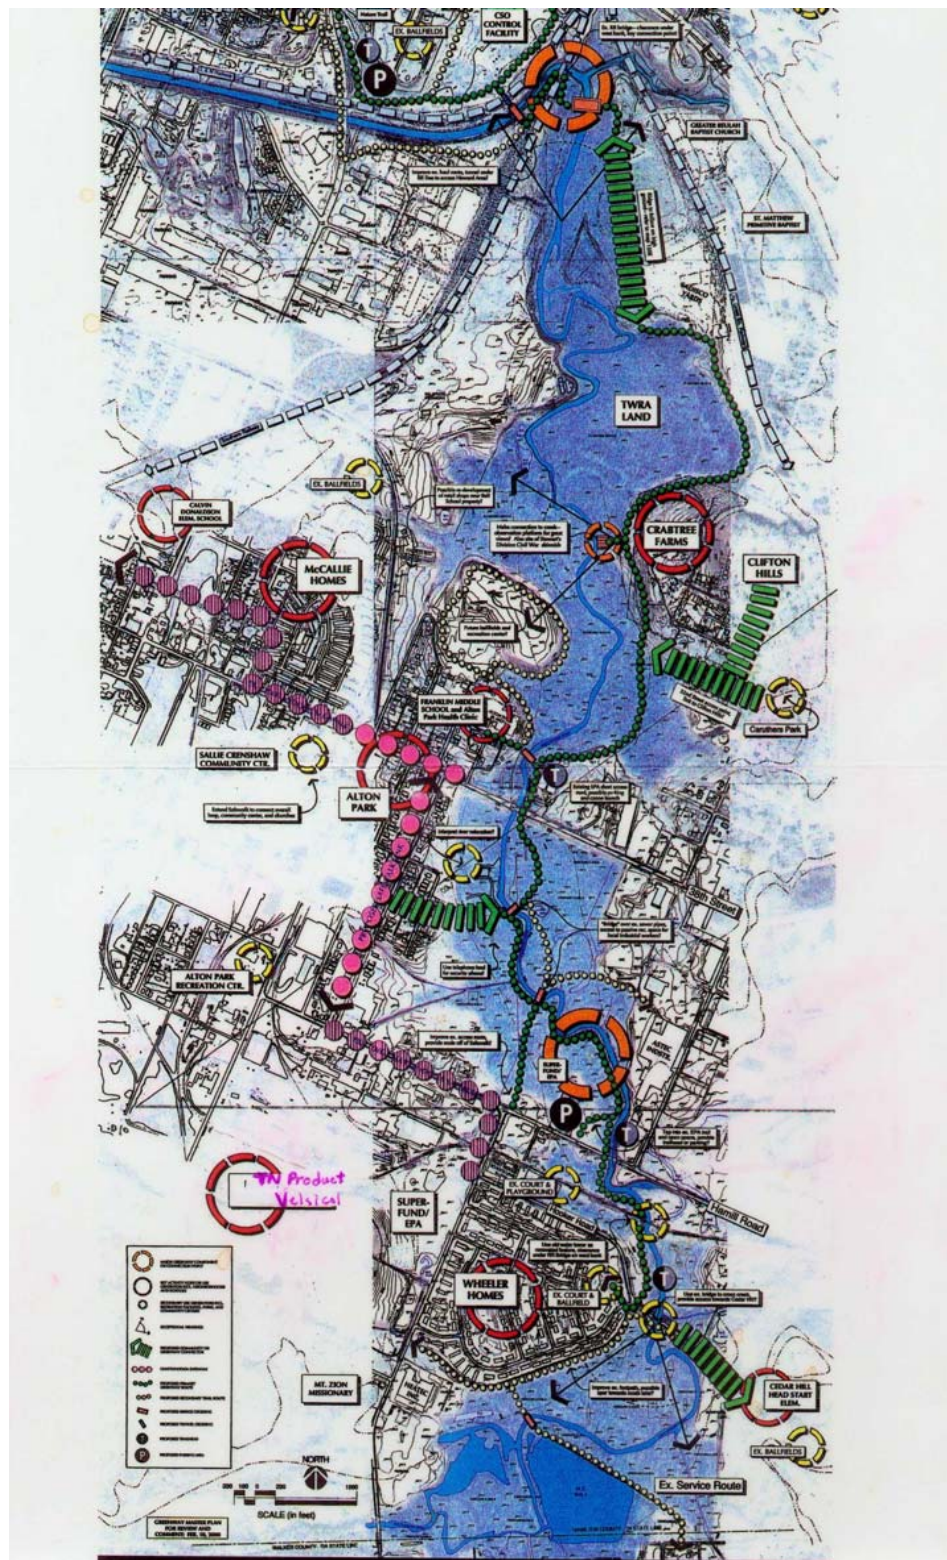
FIGURE 1 – Proposed project from the Trust for Public Land Greenway Master Plan.
Chattanooga, Hamilton County, TN
(Image credit: TPL, 2002)

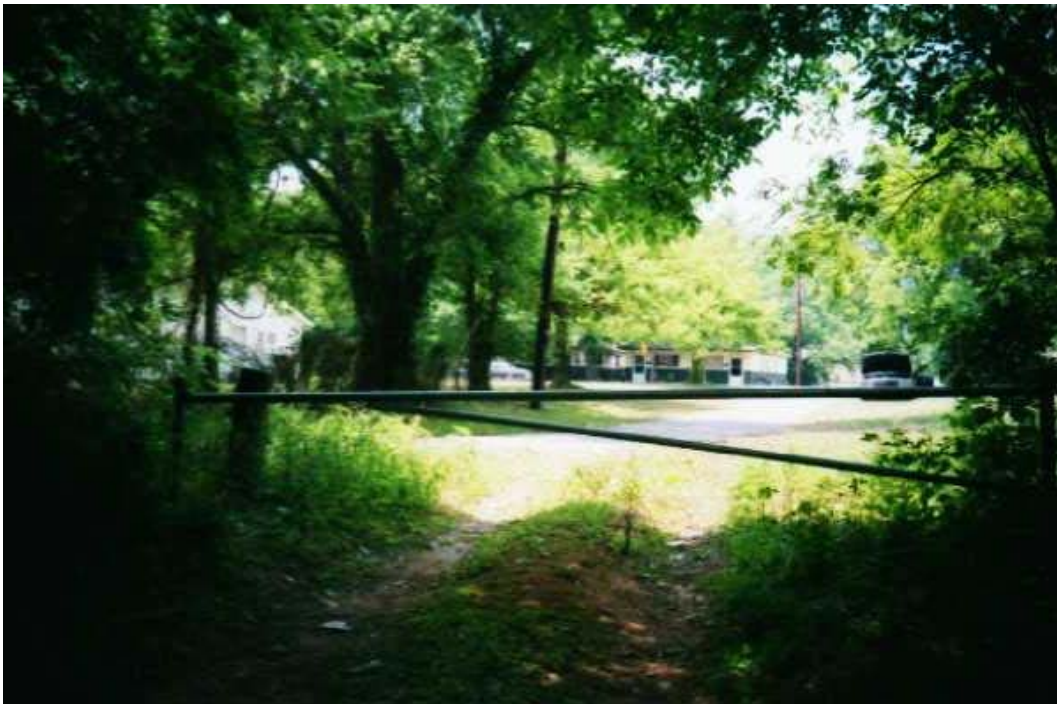
FIGURE 4 - Photo of haul road gate where it meets the community at E 42nd Street.
Chattanooga, Hamilton County, TN (Photo credit: David Borowski, TDH, 6/20/02)

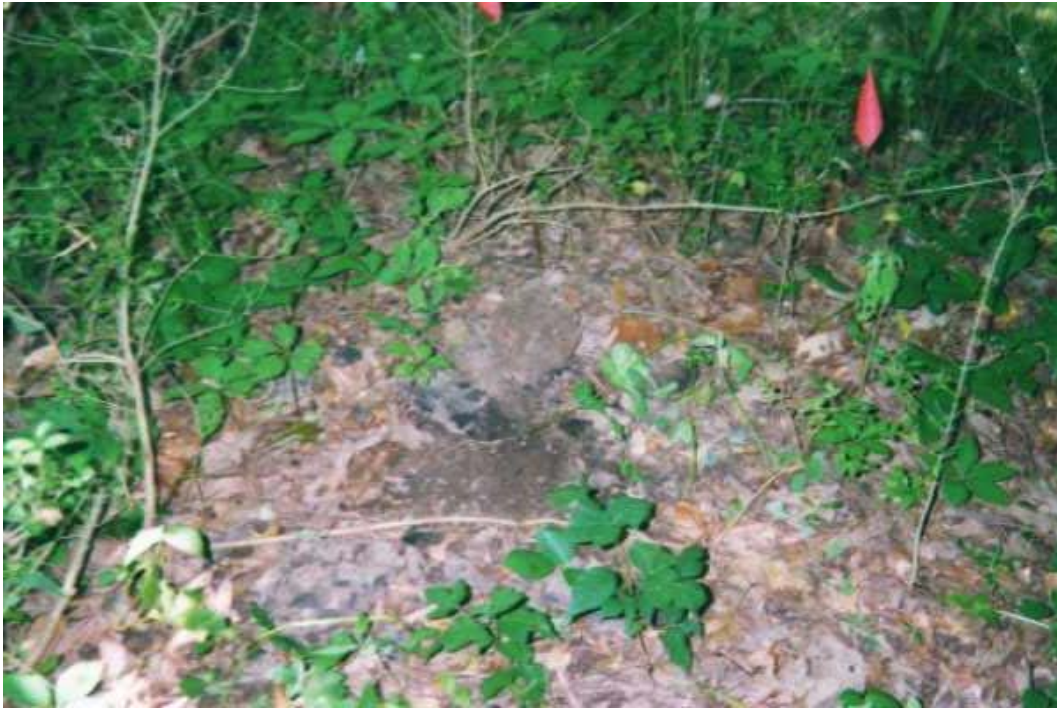
FIGURE 5 - Photo of surface-level coal tar.
Chattanooga, Hamilton County, TN (Photo credit: David Borowski, TDH, 6/20/02)

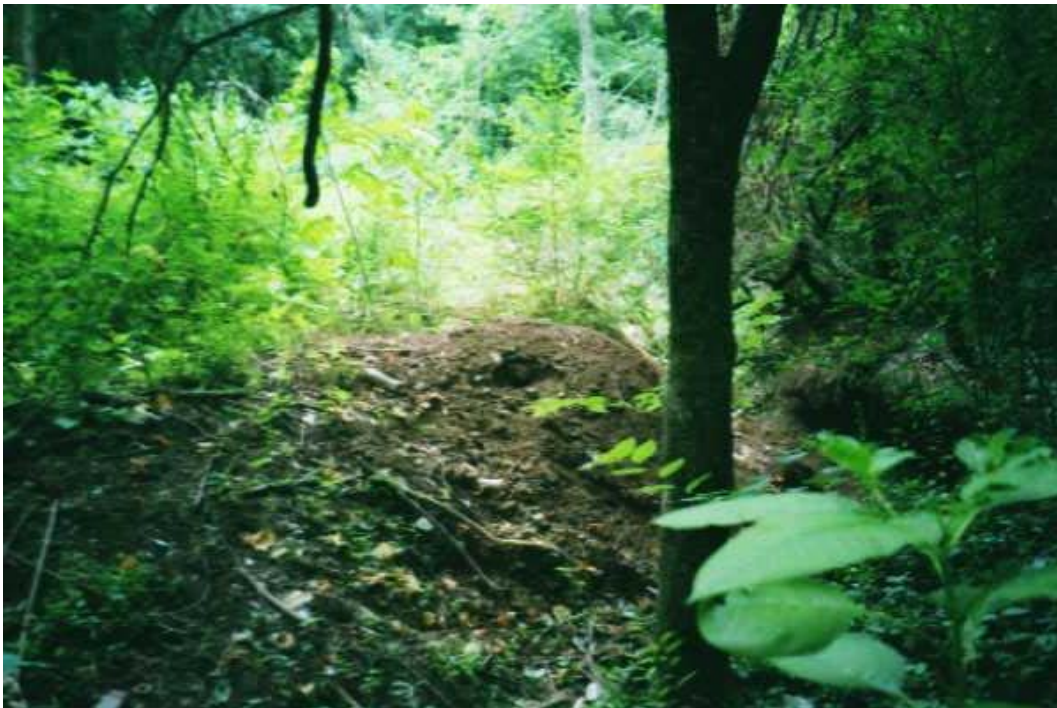
FIGURE 6 - Photo of old glass dump located within the Glover Site.
Chattanooga, Hamilton County, TN (Photo credit: David Borowski, TDH, 6/20/02)

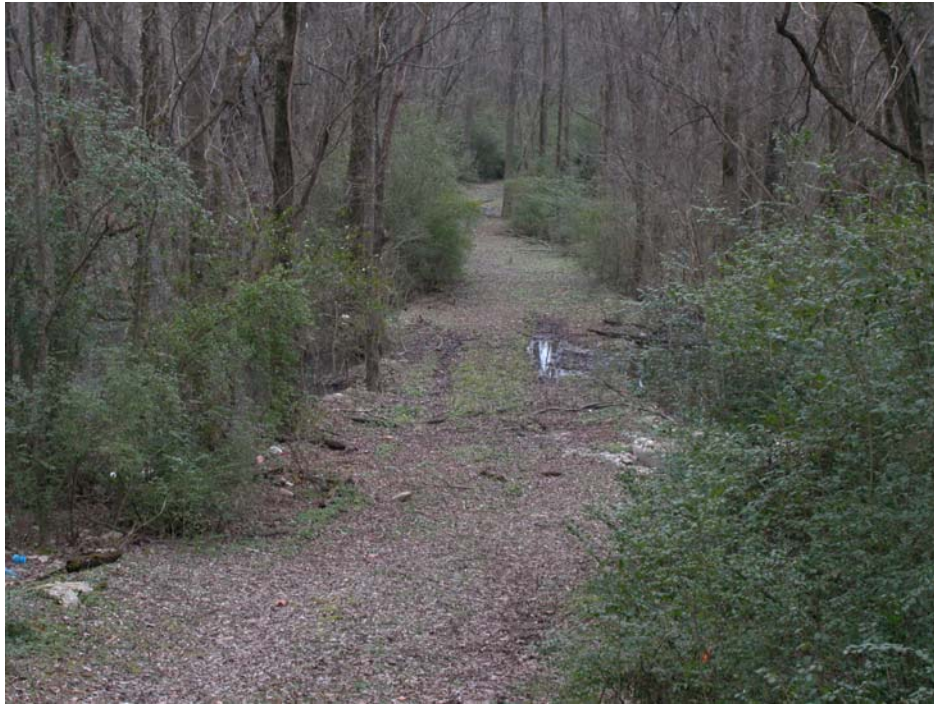
FIGURE 7 - Photo of old gravel haul roads on the Glover property.
Chattanooga, Hamilton County, TN (Photo credit: David Borowski, TDH, 01/30/04)

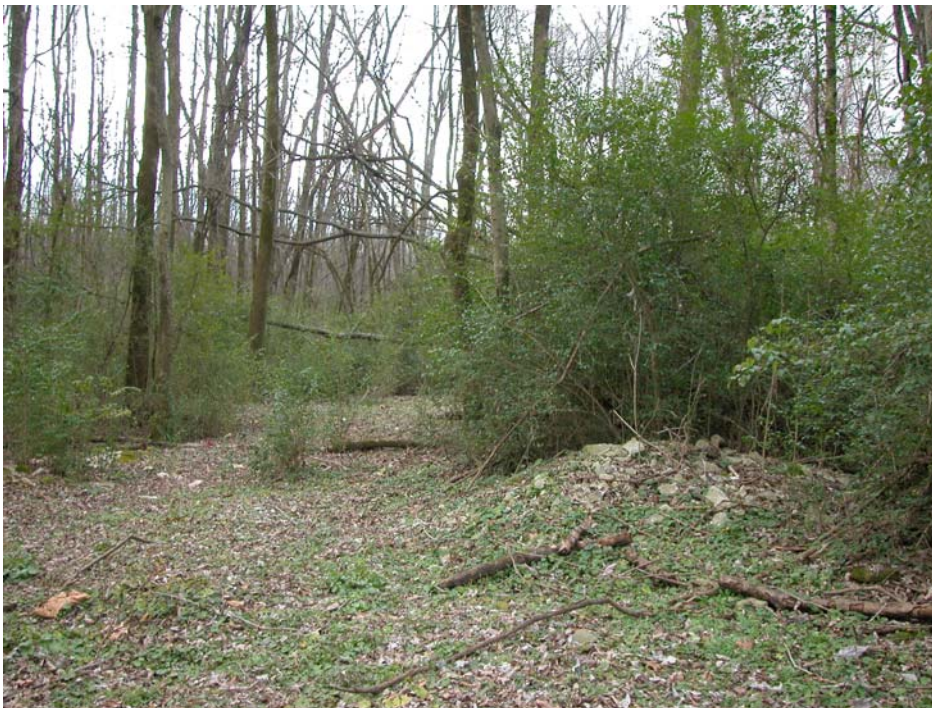
FIGURE 8 - Photo taken near known glass dump showing winter ground cover.
Chattanooga, Hamilton County, TN (Photo credit: David Borowski, TDH, 01/30/04)

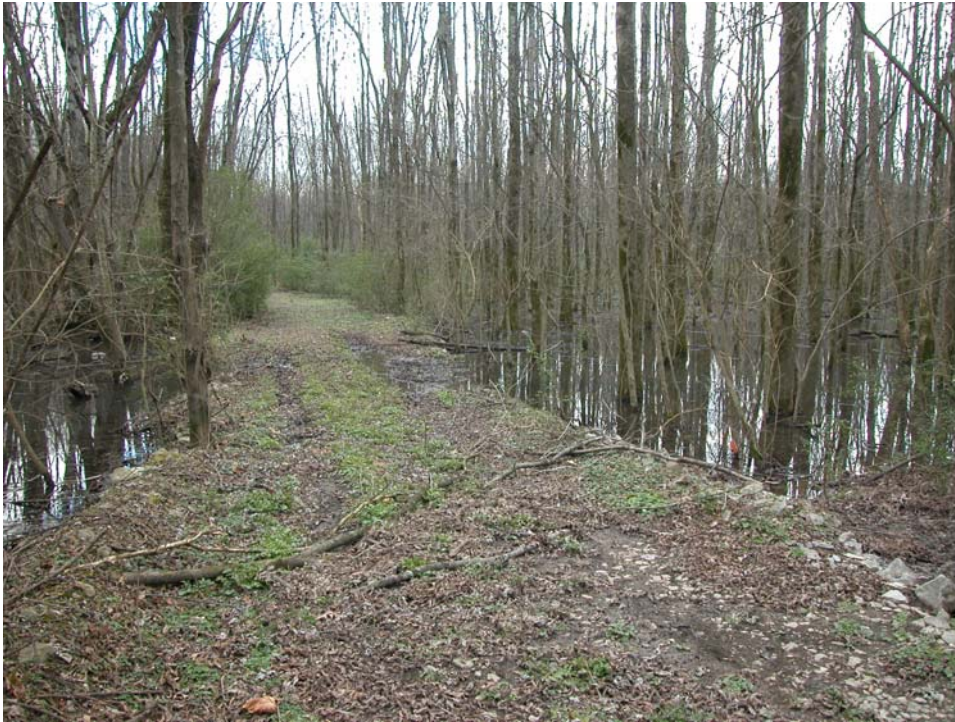
FIGURE 9 - Photo of a water-flooded portion of the Glover property.
Chattanooga, Hamilton County, TN (Photo credit: David Borowski, TDH, 01/30/04)

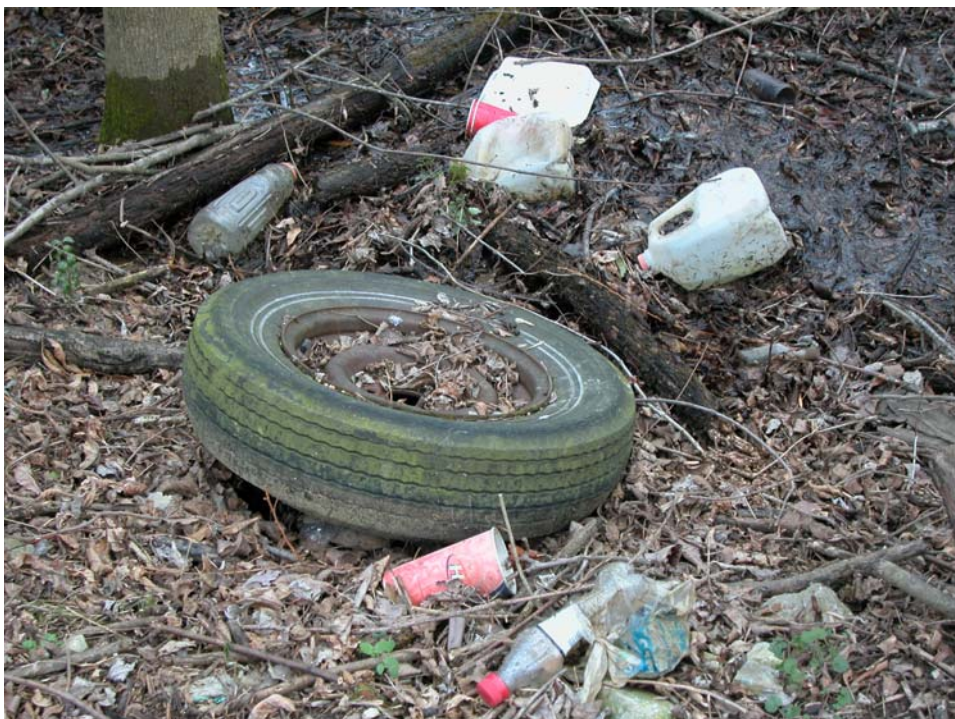
FIGURE 10 - Photo of miscellaneous trash/litter dumped on the Glover Site.
Chattanooga, Hamilton County, TN (Photo credit: David Borowski, TDH, 01/30/04)

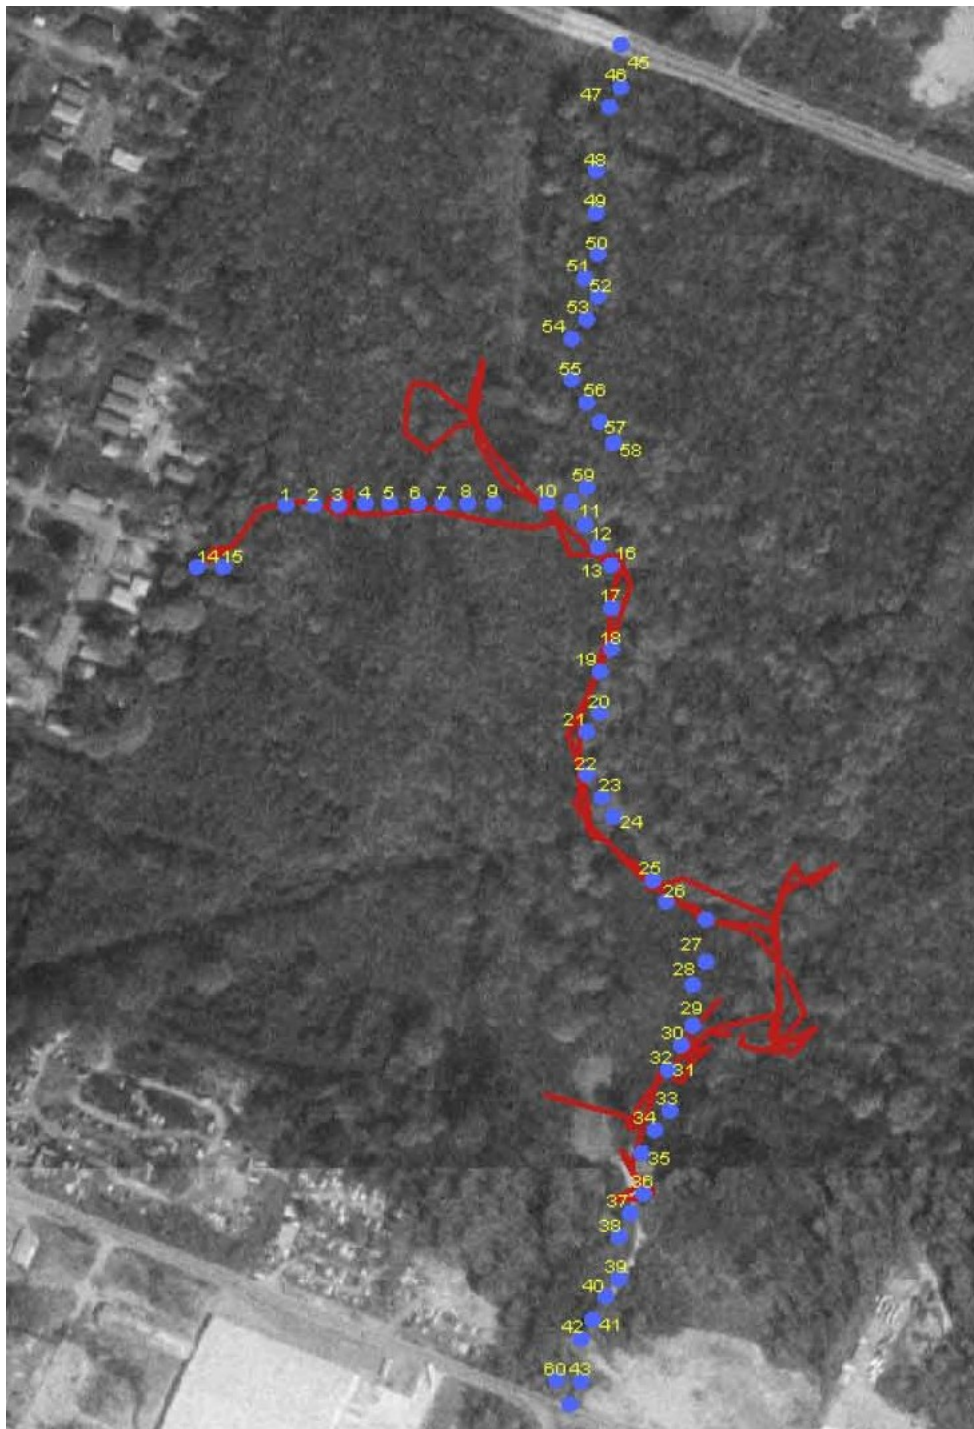
FIGURE 11 – Sampling sites on the Glover property.

blue dots = sampling sites
red line = hiked site exploration path
